QUALITY CRITERIA

FOR INSULATING GLASS UNITS

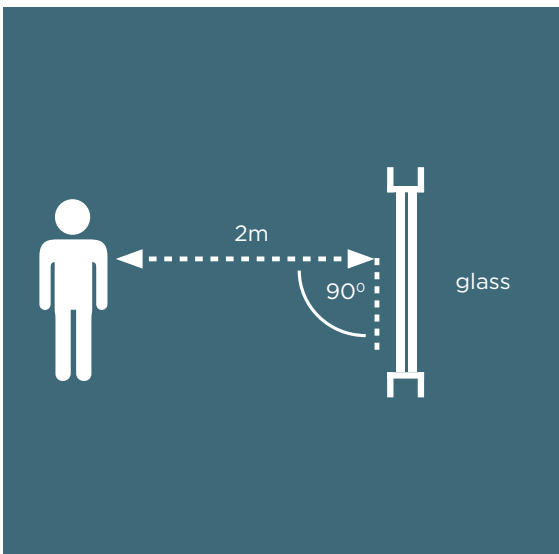
Look at the glass vertically at the right angle (90°) - this concerns the surface of the glass seen from inside the room. Stand 2 m away from the glass. Carry out the assessment in a natural daylight, but not in direct sunlight. The glass needs to be completely dry. Before inspection defects cannot be marked on the glass.

During the visual inspection you need to be looking through the glass rather than at the glass. If a defect is not visible while looking through the glass from the specified distance, it is considered that the defect is not clearly visible or disturbing to the onlooker.

While conducting the assessment you cannot use any magnification devices or sources of strong light (such as halogen lamps or flash lights). The assessment should not be performed in strong sunlight. All defects should be first identified while standing at least 2 m from the glass. If a defect is noticed, it should be measured using the right measurement tool (ruler (mm) / tape measure) and compared with the table found in this brochure.
